Dam Safety Assessment of CCW Impoundments

Edwardsport Plant

March 31, 2011

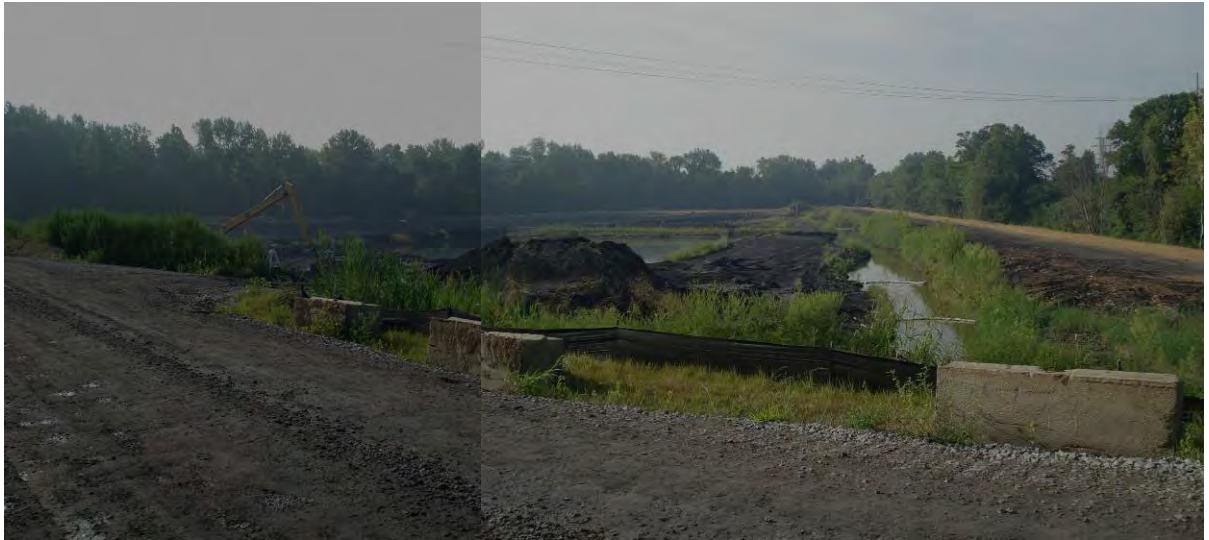
Photo Number:
1

Overview of Primary Ash Pond from northwest corner showing typical condition of crest & inboard slope. Note excavator removing dewatered ash.

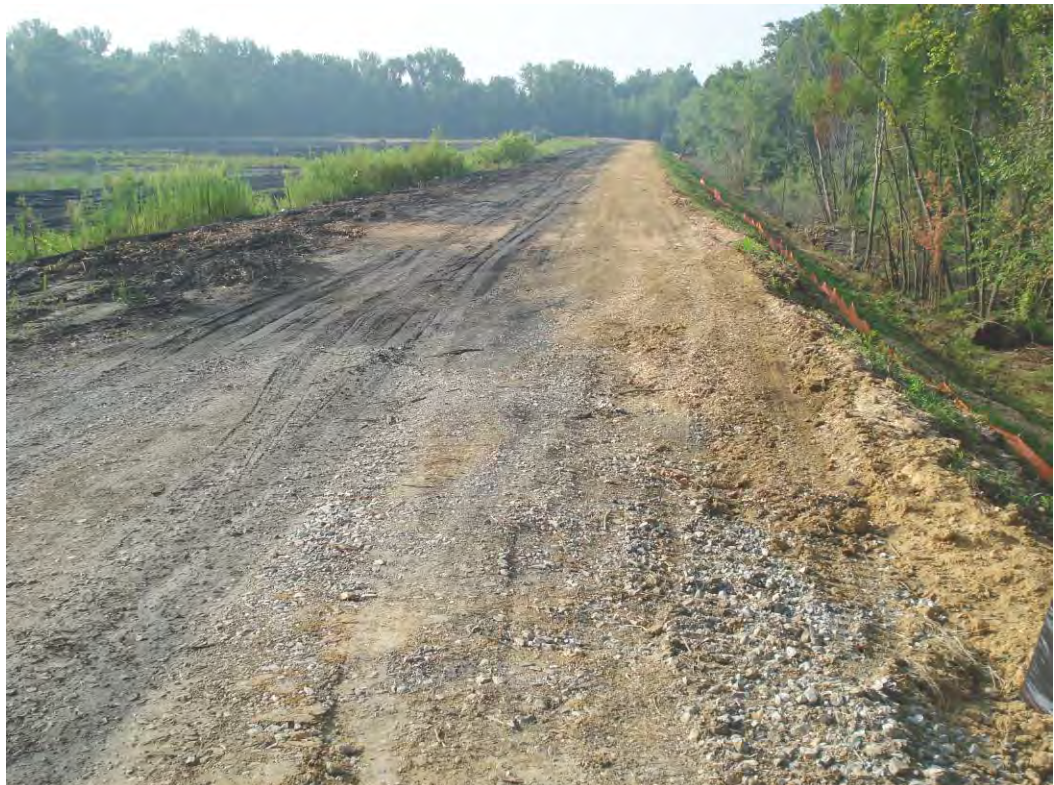
Photo Number:
2

Typical condition of Primary Ash Pond crest. Note safety fencing on outboard slope.

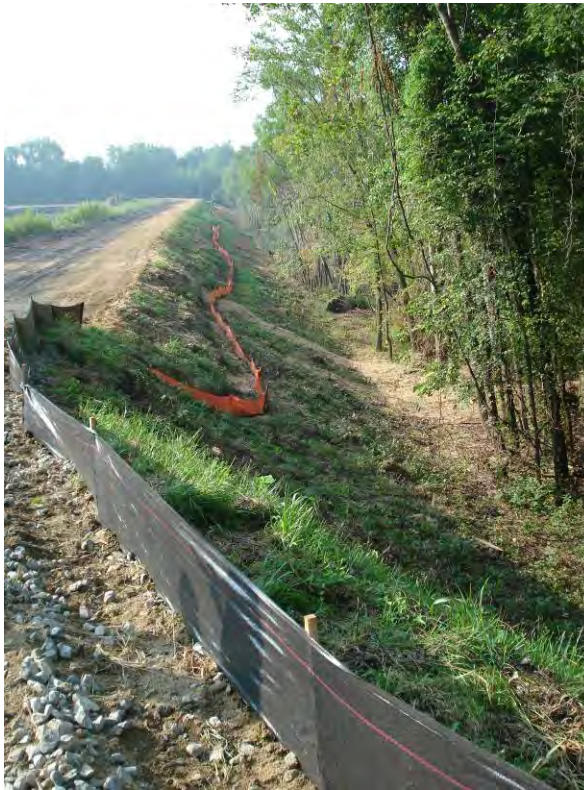
Photo Number:
3

Typical condition of Primary and Secondary Ash Pond exterior dike slopes.

- Establish turf on the outboard slopes.
- Repair the concrete apron retaining wall.
- Re-grade the western toe swale to drain the ponded water.

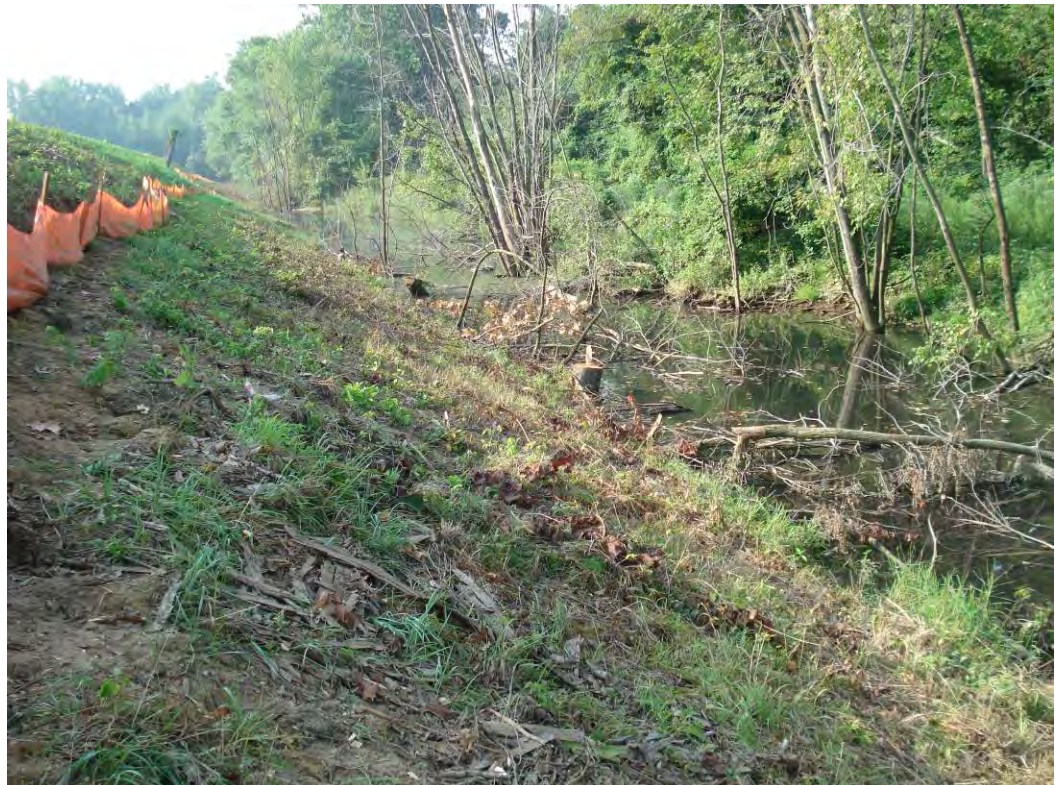
Photo Number:
4

- Ponded water was noted in the drainage swale along nearly the entire toe of the western dike (Appendix B – Photo 4). There was no evidence of piping or flow, and the ponding appeared to be caused by a low area in the swale invert. The northern and eastern toe drainage swales were dry.

Ponded water in drainage swale at Primary Ash Pond dike's western exterior toe.

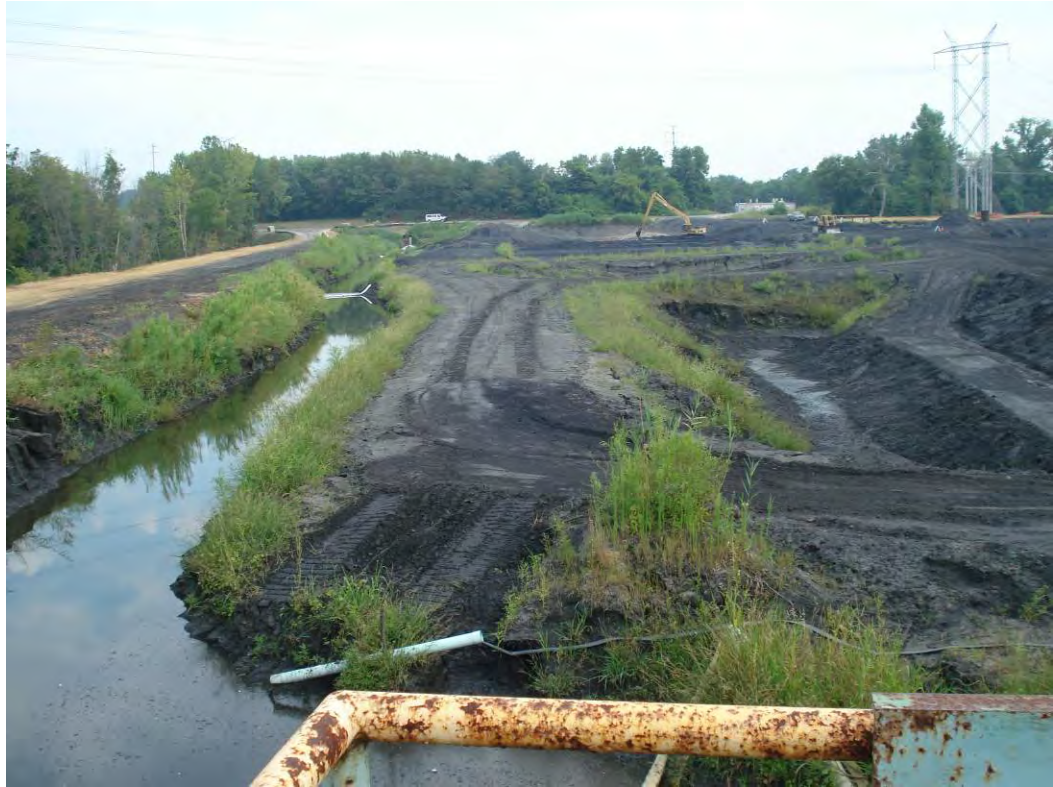
Drainage ditch from CCW and drainage inlets in Primary Ash Pond. Note excavator maintaining flow from decant inlet to ditch.

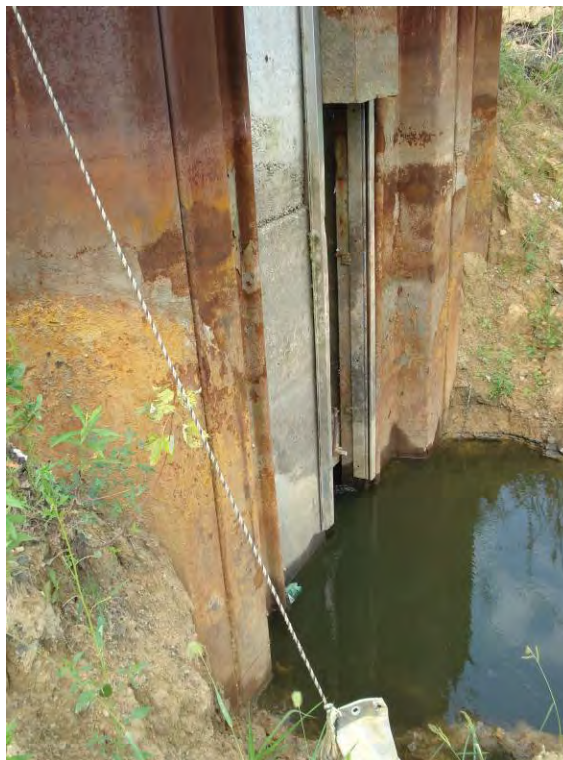
- The reinforced concrete outlet structure was in fair condition. All of its stoplogs had been removed such that the pool elevation was being controlled by the Secondary Ash Pond outlet structure.

Inlet to Primary Ash Pond outlet structure. All stoplogs have been removed to facilitate dewatering and removal of CCW.

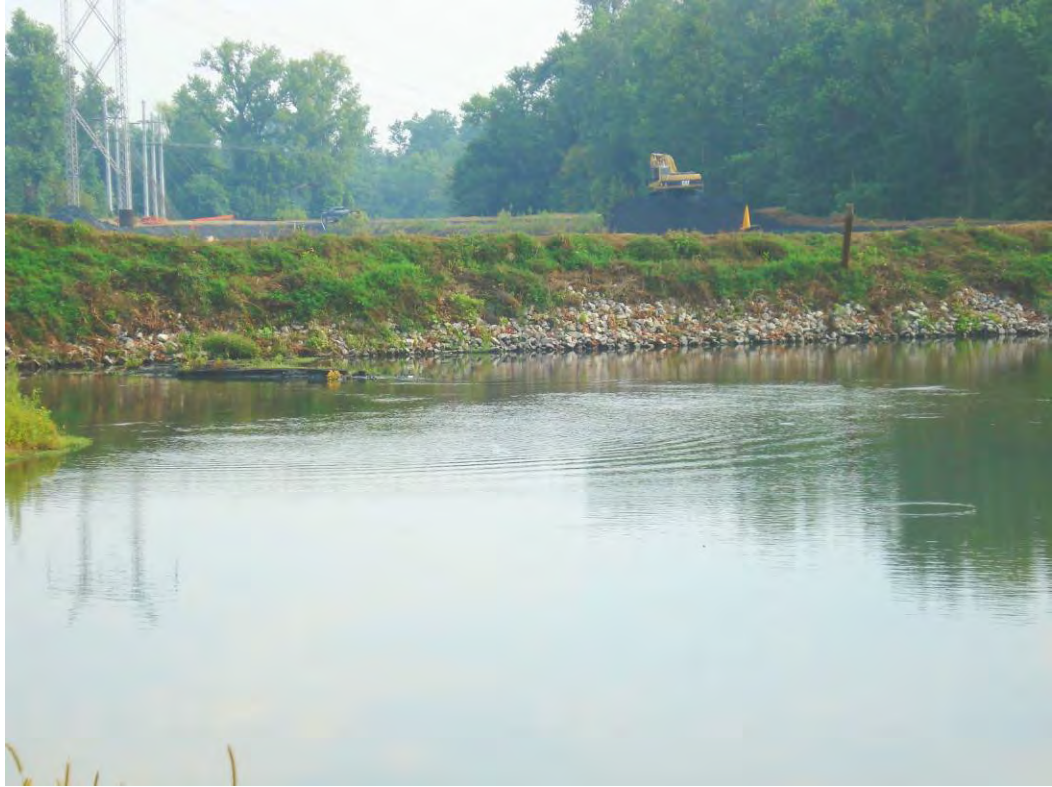
Photo Number:
7

- Supernatant from the Primary Ash Pond enters the Secondary Ash Pond below the latter's pool elevation (El. 454) (Appendix B – Photo 7).
- The interior riprap was in good condition and the inboard slope above the riprap was covered with grass about 8 inches long (Appendix B – Photo 7).

Typical condition of dividing dike slope. Mild turbulence in Secondary Ash Pond water surface from Primary Ash Pond outlet conduit. Note excavator stockpiling dewatered Primary Pond ash.

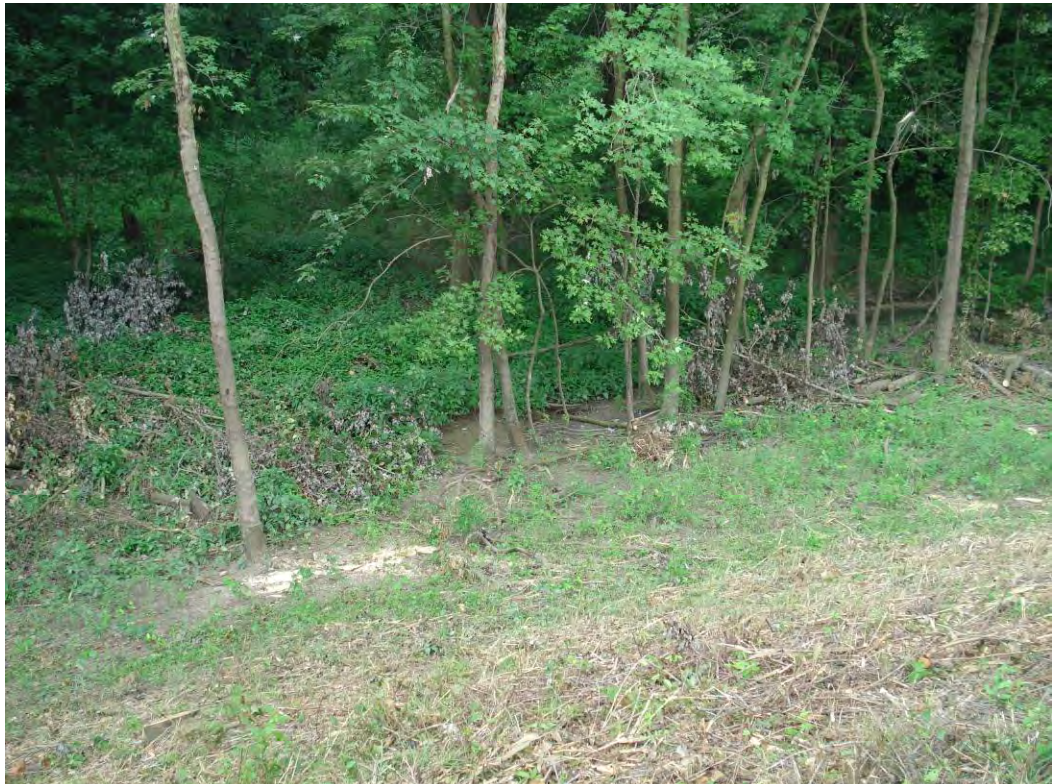
Photo Number:
8

Typical condition of southern toe of Secondary Ash Pond.

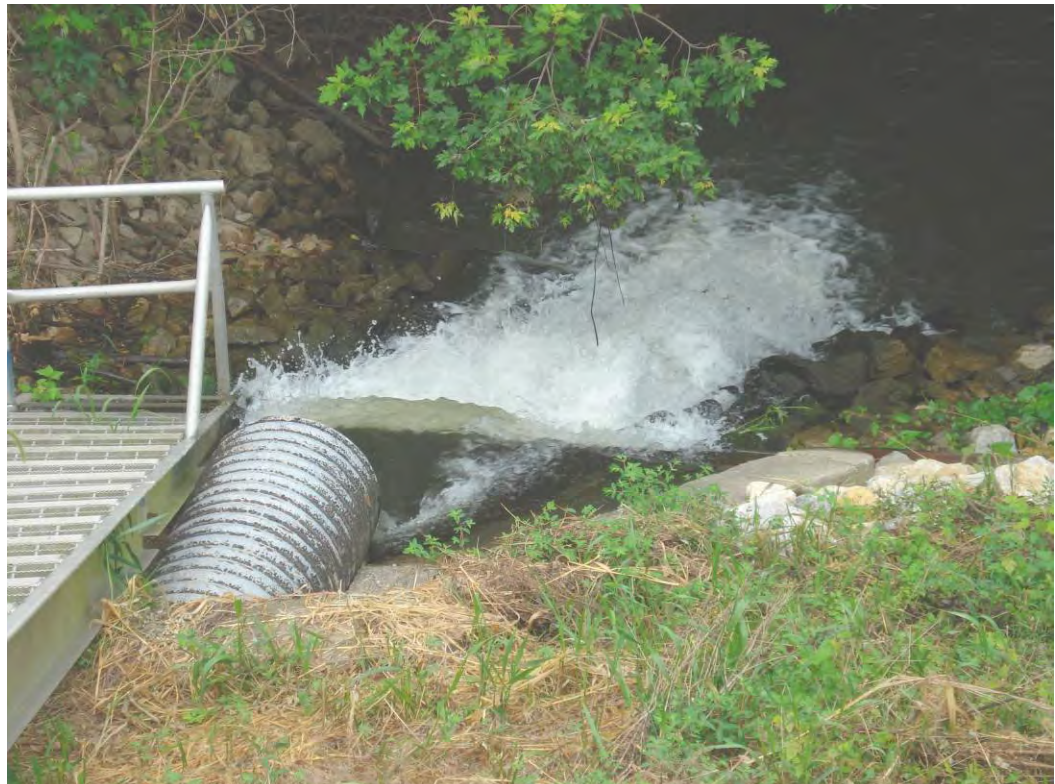
Photo Number:
10

18-inch outlet from Secondary Ash Pond.

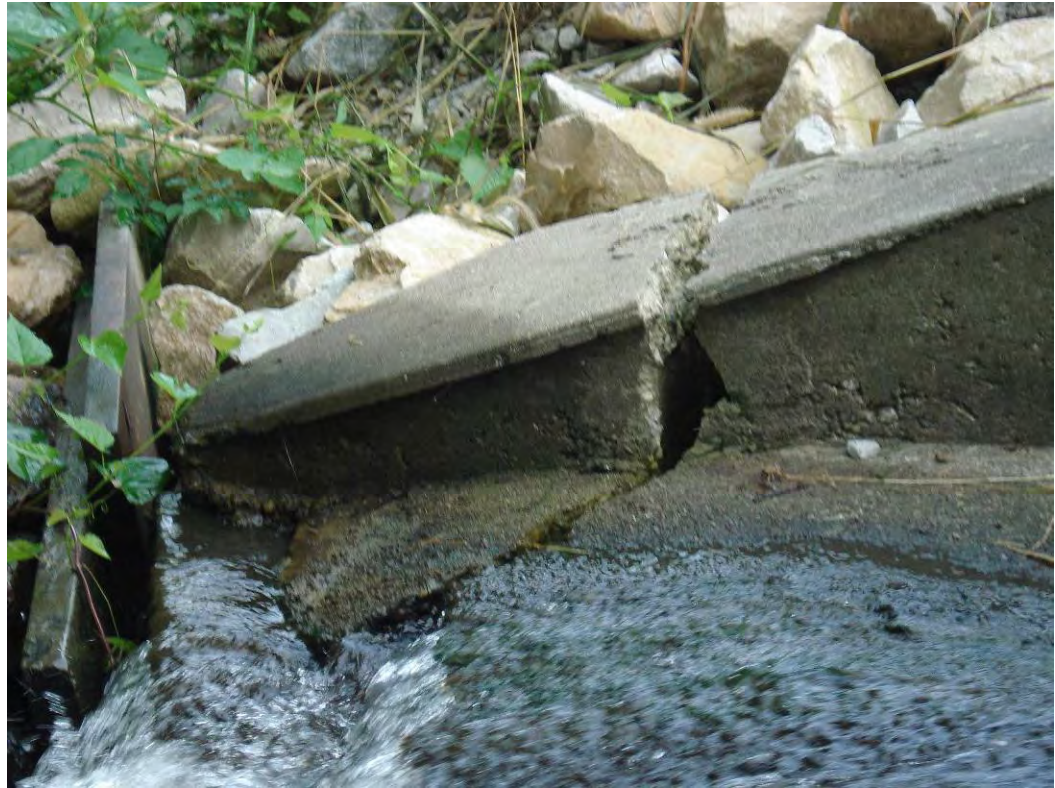
Photo Number:
11

- The outlet conduit discharges onto a concrete apron about 5 feet above the drainage channel invert. The apron terminates in a concrete headwall which was not undermined. The apron's southern concrete training wall was cracked about two feet above its downstream terminus (Appendix B – Photo 11).

Cracked
southern
retaining wall of
Secondary Ash
Pond outlet
apron.

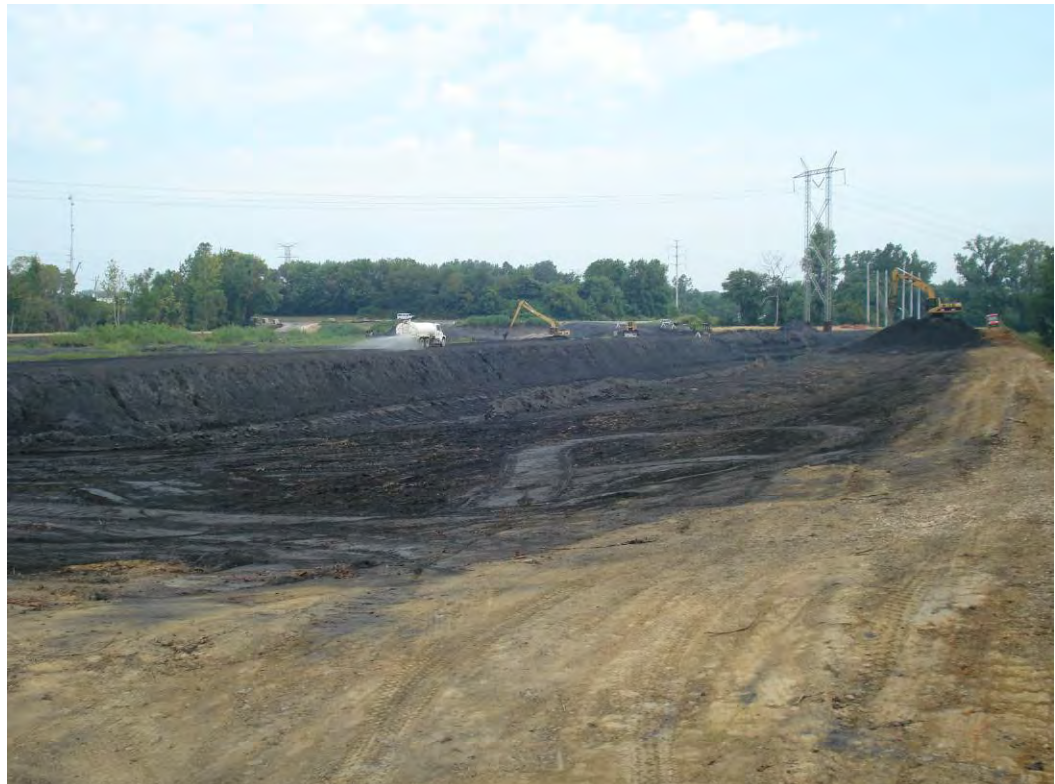
Photo Number:
12

Ash removal
from Primary
Ash Pond.
